Asbestos Building Materials Assessment

House
891 Boundary Street
Prescott ON

Project No.: 122150275

February 15, 2017

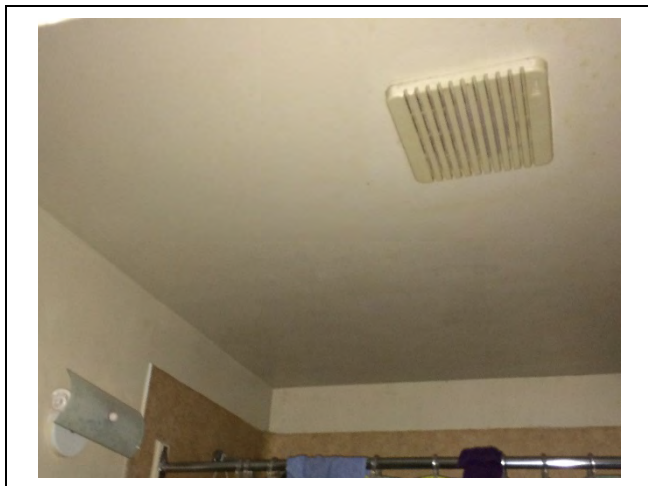
This material was observed to be in good condition. It should be noted that drywall joint-fill compound is considered non-friable in its undisturbed state but can release fibers when damaged.

Photo 3: Asbestos-containing drywall joint-fill compound observed on the walls and ceiling.

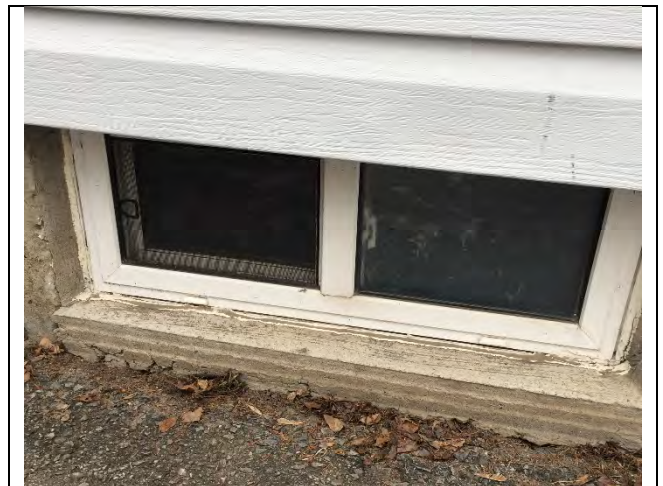
Photo 4: Presumed asbestos-containing exterior caulking – white was observed on the exterior window.
