Asbestos Building Materials Assessment

Row Houses
518, 550, 555, 563, and 574 Fort Town
Drive, Prescott ON

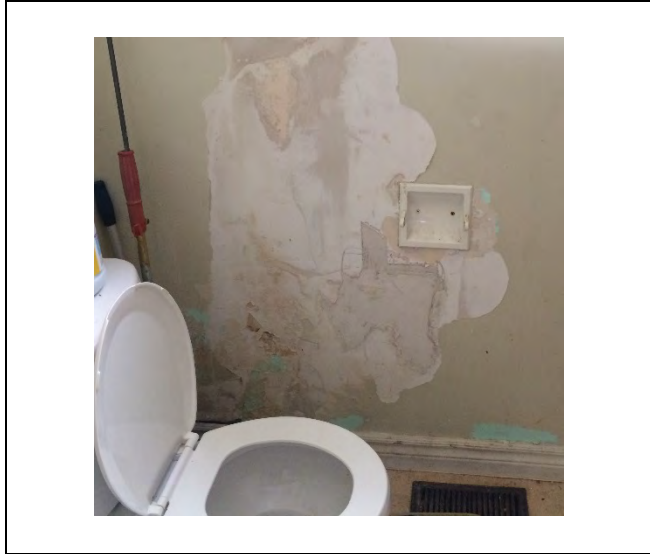
Photo 1: Asbestos-containing drywall joint-fill compound observed to be in poor condition on wall in the washroom at 555 Fort Town Drive.

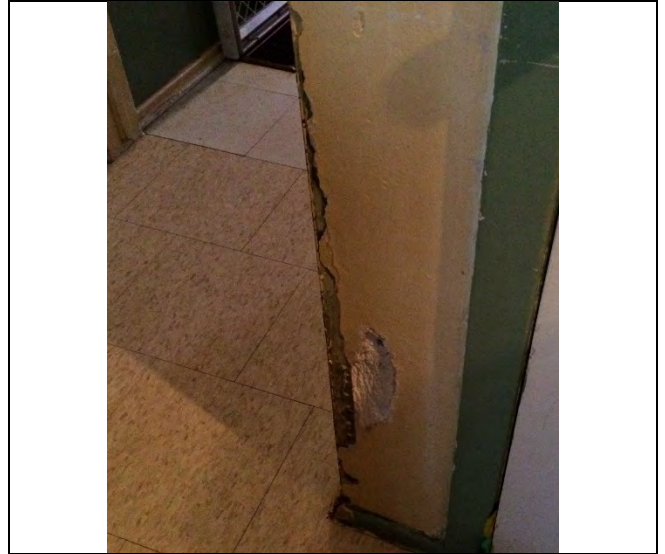
Photo 2: Asbestos-containing drywall joint-fill compound observed to be in poor condition on the kitchen wall at 574 Fort Town Drive.

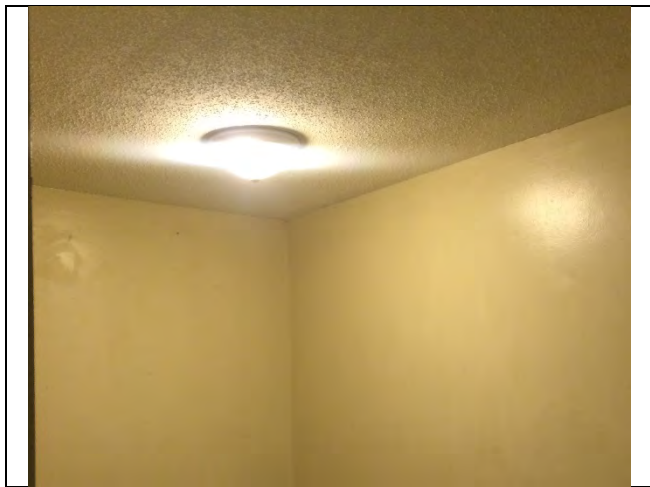
Photo 3: Asbestos-containing drywall joint-fill compound and stucco observed at 550 Fort Town Drive.

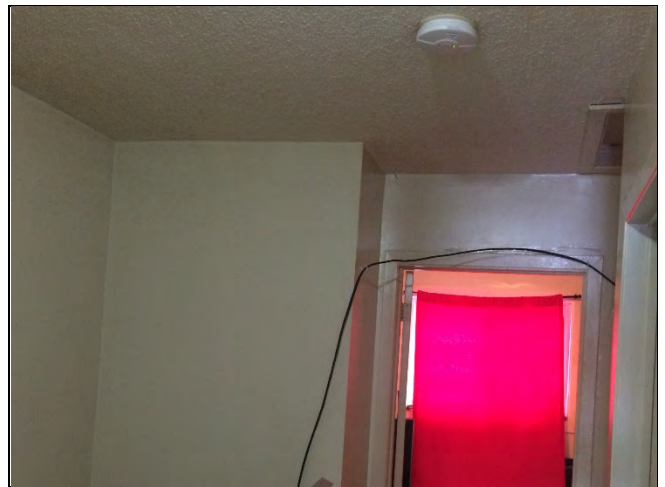
Photo 4: Asbestos-containing drywall joint-fill compound and stucco observed on walls and ceiling at 518 Fort Town Drive.

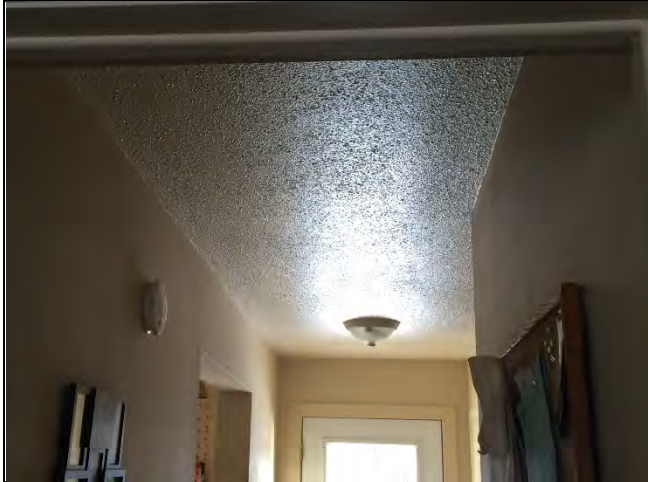
Photo 5: Asbestos-containing stucco and drywall joint-fill compound observed at 563 Fort Town Drive.

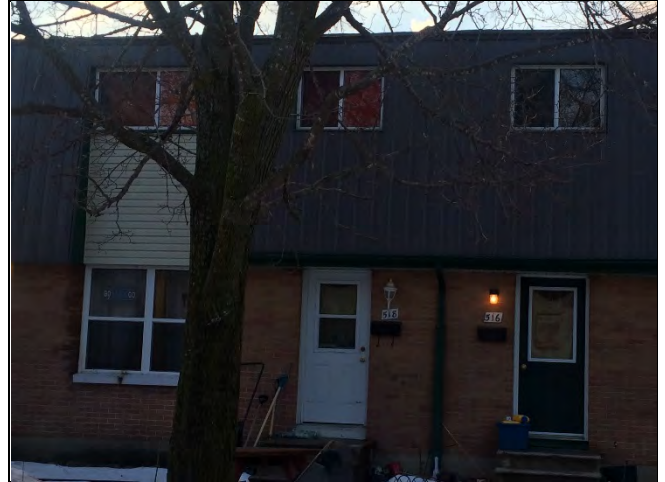
Photo 6: Presumed asbestos-containing brick mortar observed to be present on the exterior walls.
