Asbestos Building Materials Assessment

Row Houses
280 and 284 Bartholomew Street
Brockville ON

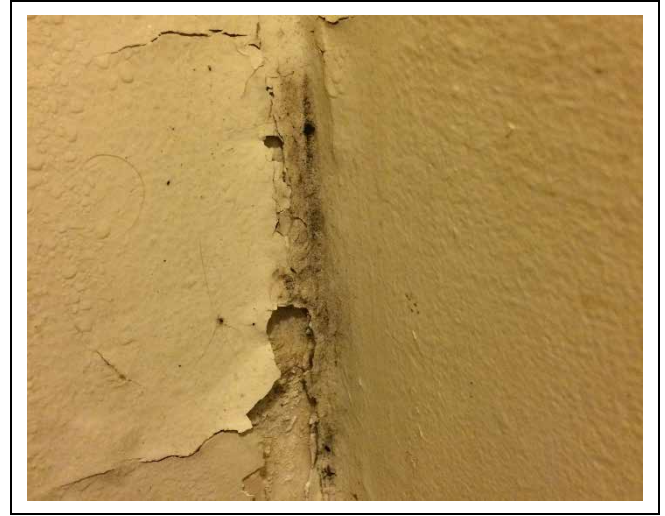
Photo 2: Asbestos-containing drywall joint-fill compound observed to be in poor condition on the wall in the foyer at 280 Bartholomew Street Unit #4.

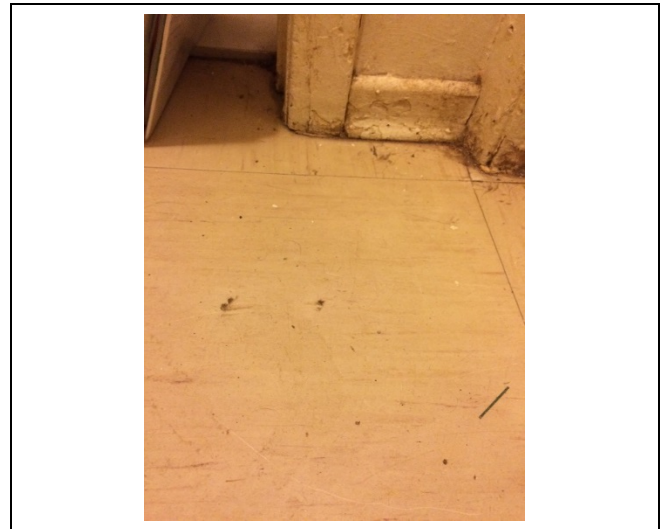
Photo 4: Asbestos-containing 12"x12" vinyl floor tiles – beige with brown streaks observed to be in good condition on the basement landing at 280 Bartholomew Street Unit #4.

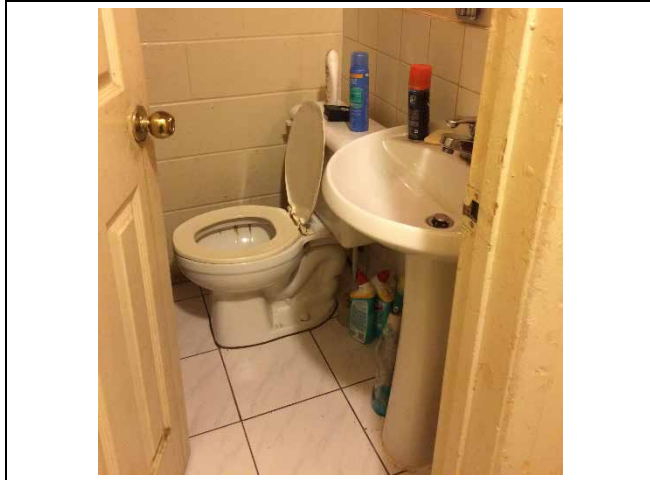
Photo 5: Presumed asbestos-containing ceramic tile grout and mortar/adhesive observed to be in good condition on the walls and floor of the basement level washroom.

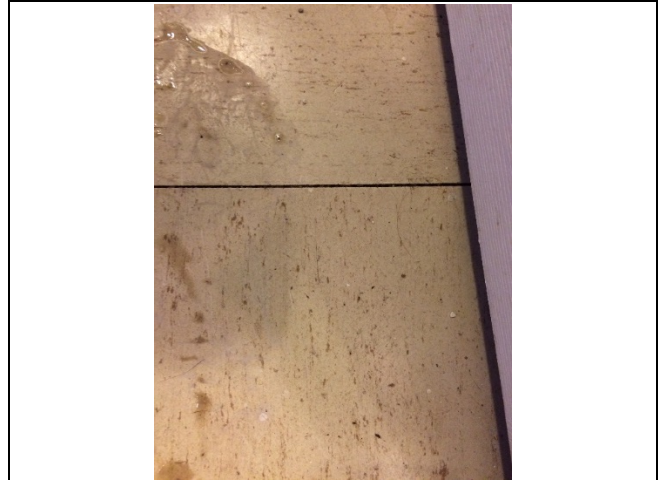
Photo 6: Asbestos-containing 12"x12" vinyl floor tiles – beige with black flecks observed to be in good condition on the basement landing at 280 Bartholomew Street Unit #8.

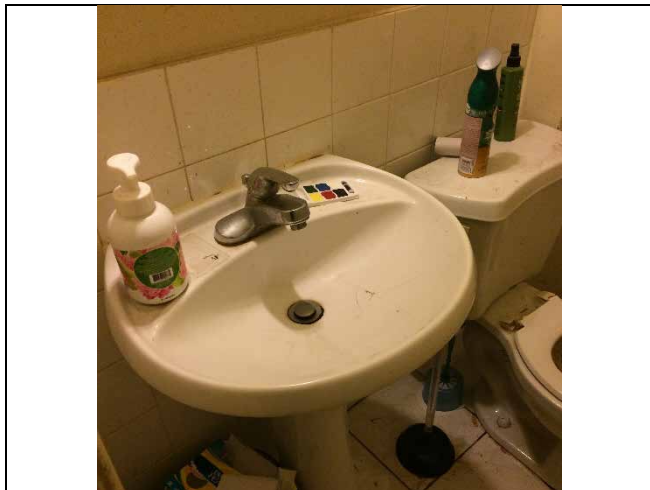
Photo 7: Asbestos-containing drywall joint-fill compound on the walls and presumed asbestos-containing ceramic tile grout and mortar/adhesive on the walls and floor in the washroom, observed to be in good condition at 284 Bartholomew Street Unit #4.
