Existing Conditions Report

United Counties of Leeds and Grenville
**Class EA for Four Lane Upgrade of CR43
Existing Conditions Report**

August, 2009

**Re: Municipal Class Environmental Assessment for
Four Lane Upgrade of County Road 43, Kemptville Corridor
Existing Conditions Report**

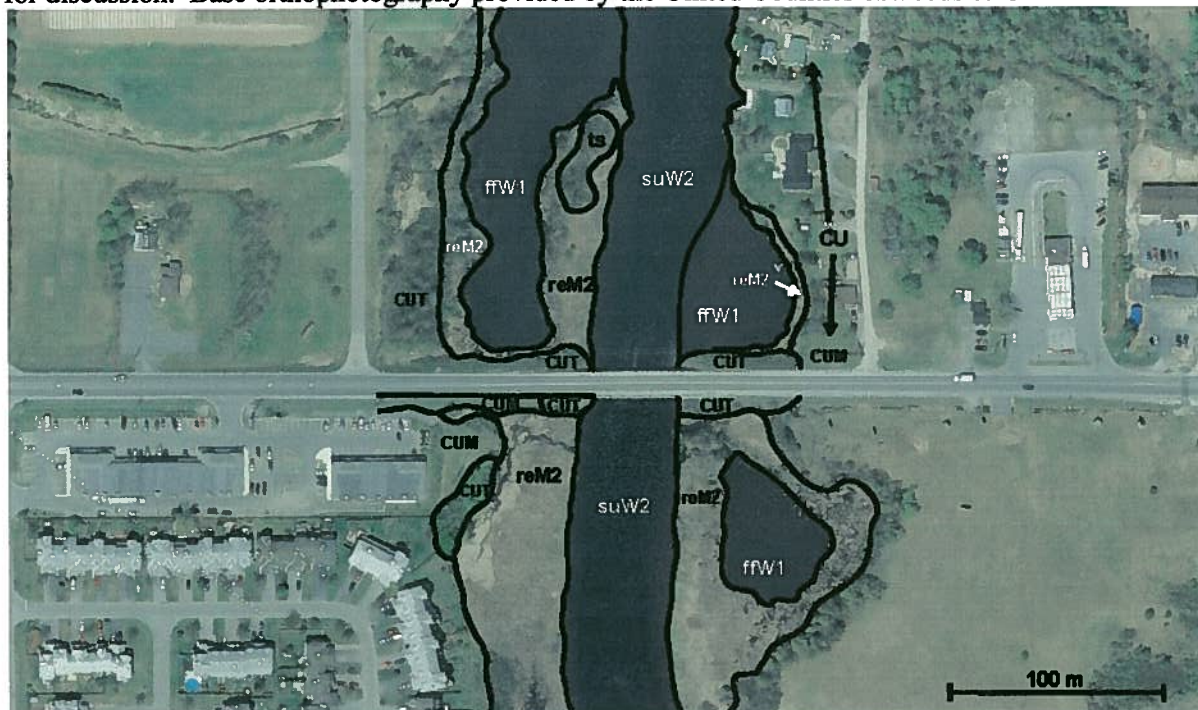
Attachment 4. Ecological land classification mapping (after Lee *et al.* 1998) along County Road 43 at Kemptville Creek (south branch of the Rideau River), Section C. CUM = Cultural Meadow; CUT = Cultural Thicket; ffW1 = free-floating wetland; suW2 = submerged wetland; reM2 = robust emergent wetland; and ts = tall shrub wetland. See text for discussion. Base orthophotography provided by the United Counties of Leeds & Grenville.

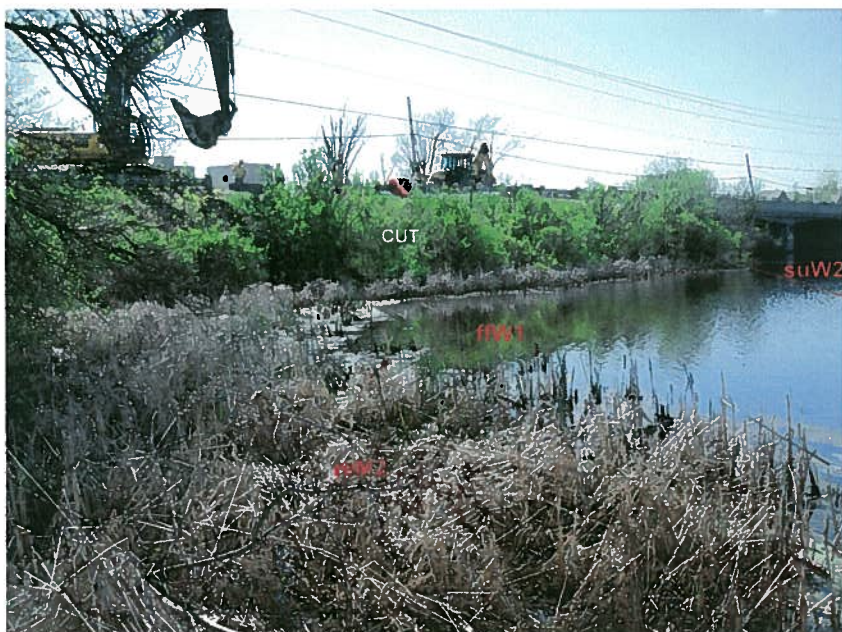
Photo 1. View to the south from the north side of CR-43, east side of Kemptville Creek. Note the steep slopes adjacent to CR-43, and the more gentle natural slopes further north from the road. The photo is annotated with some of the wetland vegetation types referred to in the report. Note also the bridge over the creek at the far right of the image, showing its existing clearance above the water surface.

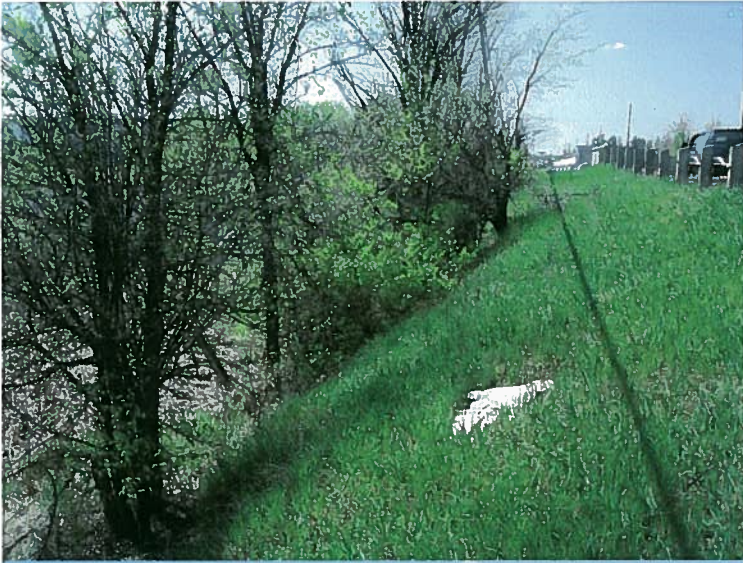
Photo 2. View to the west along the south side of CR-43. Note the steep slopes immediately adjacent to CR-43. The Cultural Thicket area can be seen on the lower part of the slope, and Robust emergent (cattail) at its base.

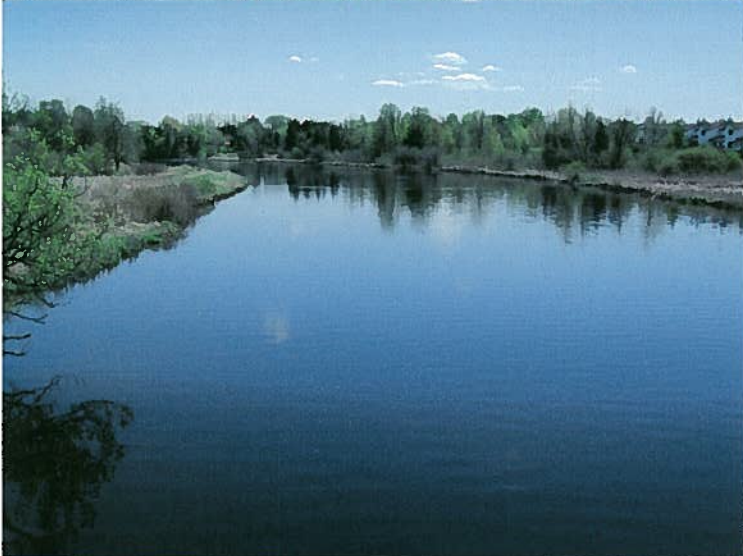
Photo 3. View to the south along the channel of Kemptville Creek from the bridge over CR-43. Note robust emergent (cattail) vegetation on each side of the creek.

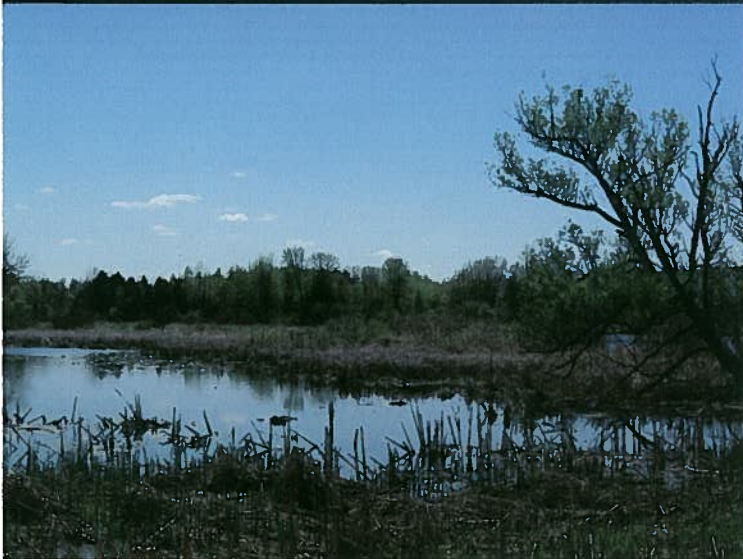
Photo 4. North side CR-43, west side of Kemptville Creek: view to the north, across the open ffW1 wetland type toward the finger of robust emergents and tall shrubs. The main channel of the creek is beyond the finger, in the far distance.

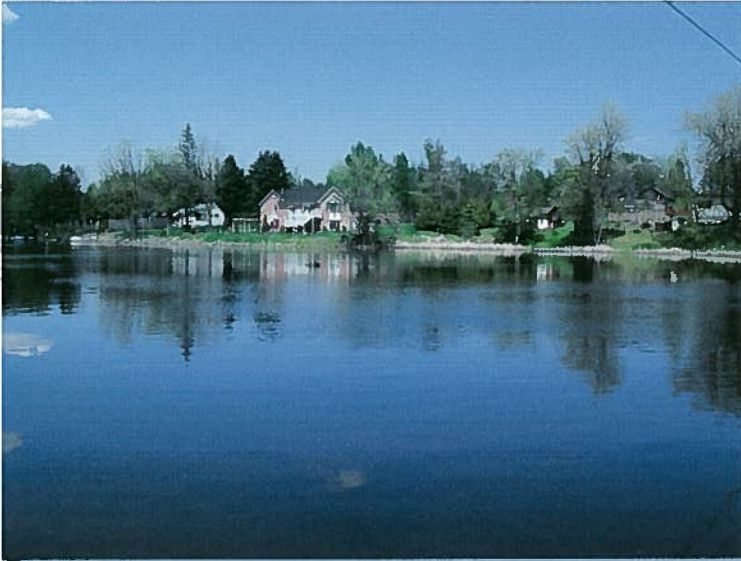
Photo 5. North side CR-43: view of the eastern shoreline of Kemptville Creek, with residential development and wetland pushed back to the water's edge.

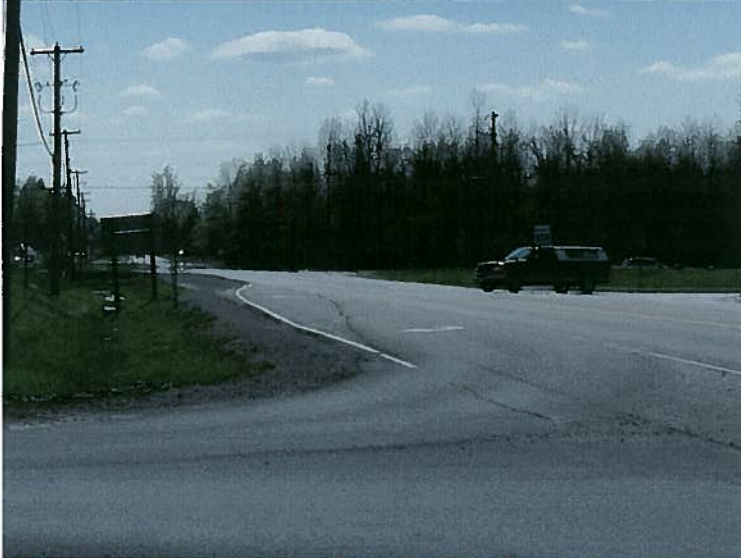
Photo 6. View to the west along CR-43 towards the western end of the study area. Note the patch of Deciduous Swamp on the north side of the road, and the cultural natural of the balance of the lands.

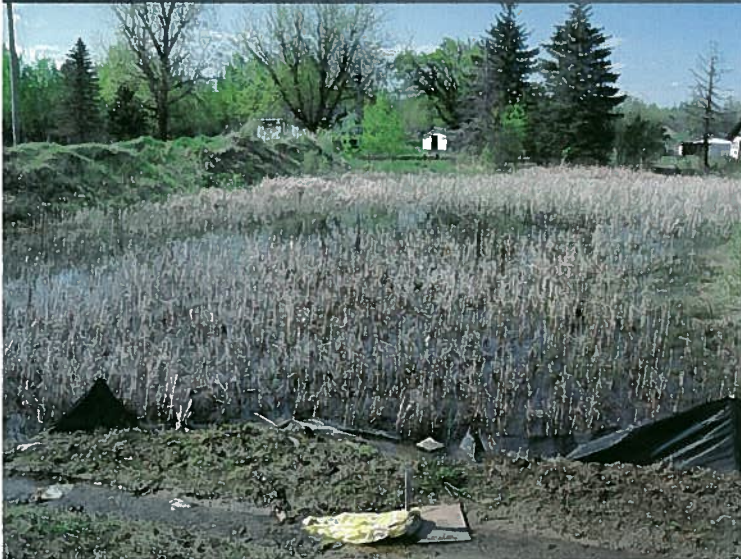
Photo 7. North side CR-43, toward the east end of the study area. Note the area of Shallow Marsh, a small, isolated patch just north of the road.

- Shallow Marsh (MAS) was found in a couple of small patches on the north side of CR-43. The easterly of these appeared to have been created by road construction and manipulation of soils (see Attachment 6). The westerly patch may be connected to an area of Deciduous Swamp (SWD) further to the north, but we did not investigate this area as it is well beyond the CR-43 right-of-way.

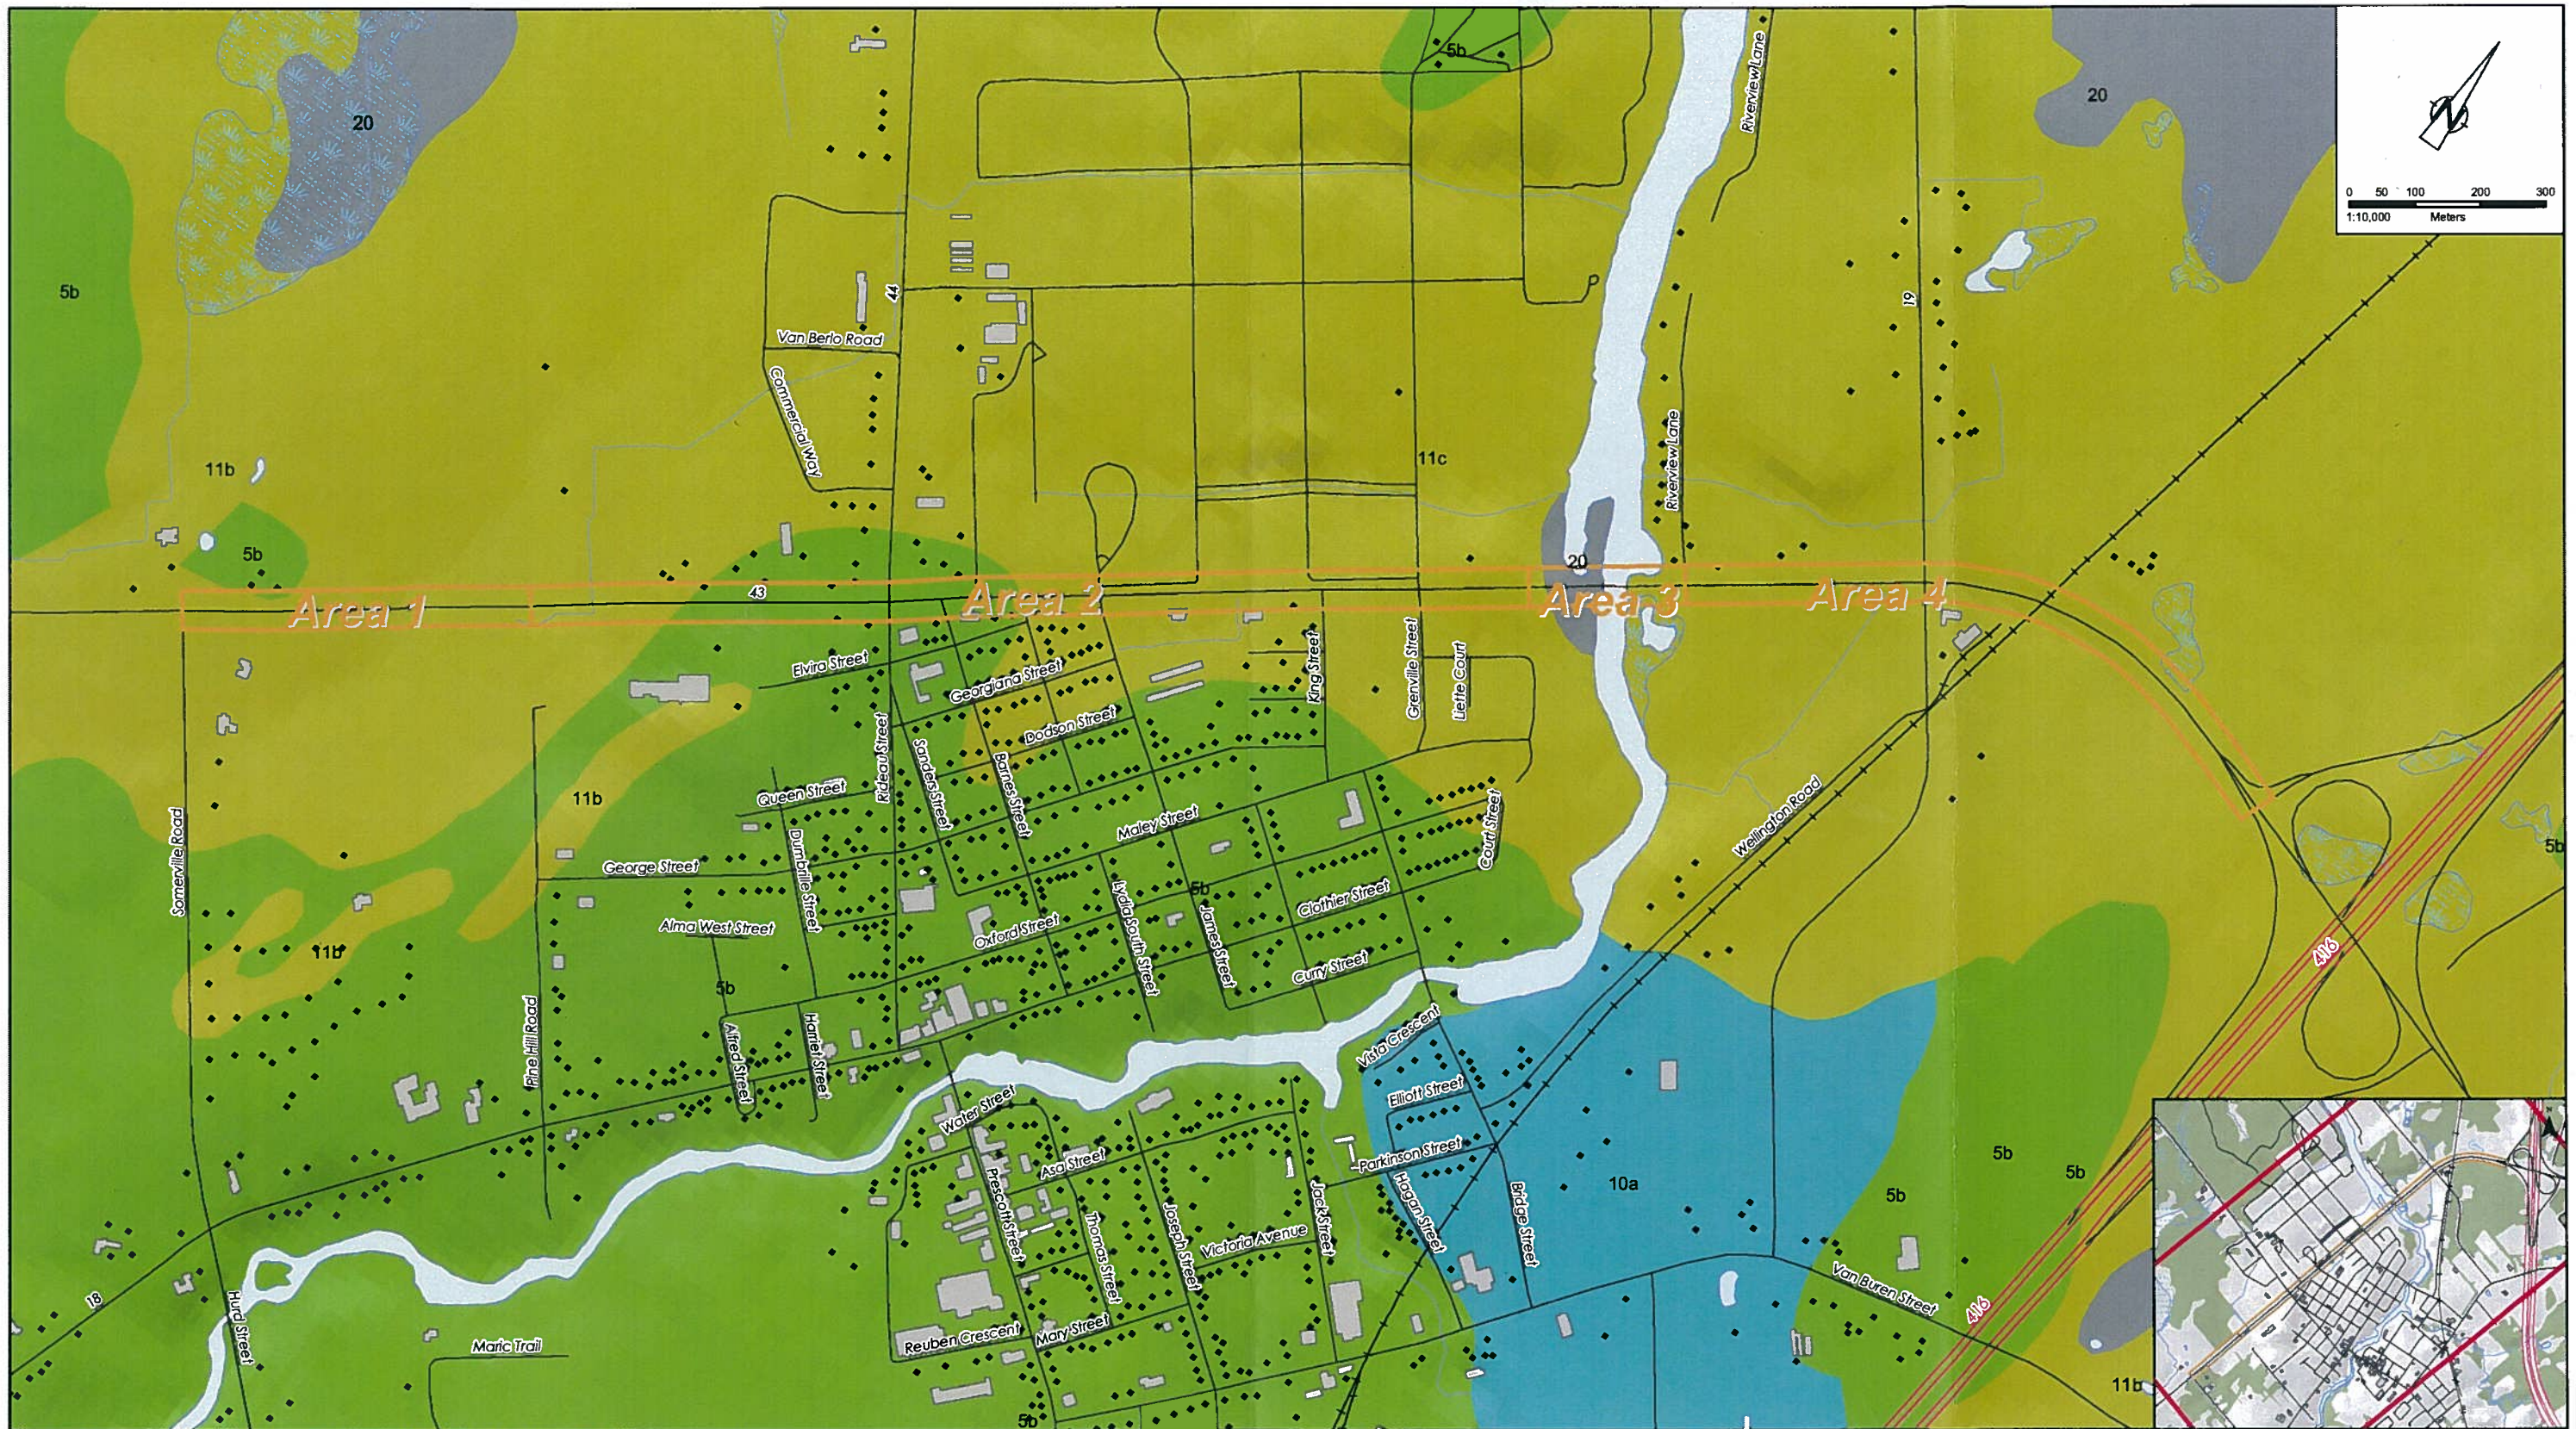
Project No.: T020613-A1
 Class Environmental Assessment – Geotechnical Study
 Ontario Soils of Kemptville Corridor
 Leeds and Grenville County Road 43 from Somerville Road to Colonnade Road
 Town of Kemptville, Ontario

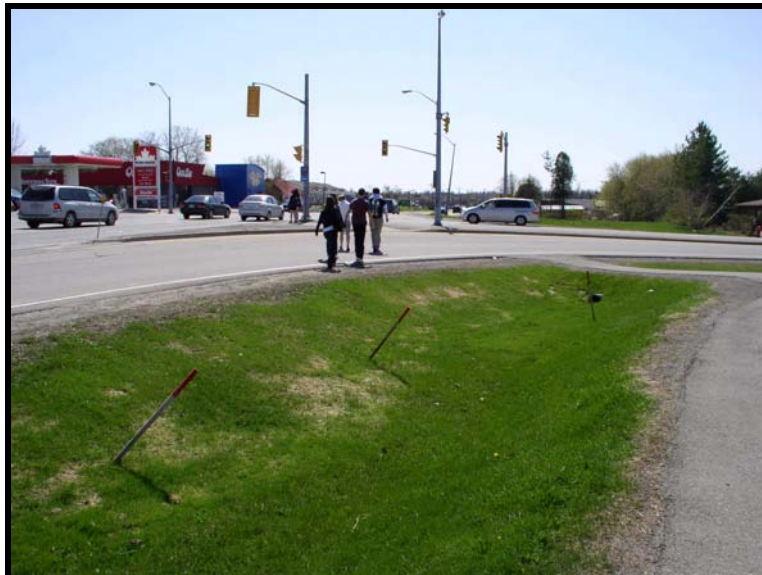
The conducted counts included tracking of pedestrians within the corridor. The only location that had more than five pedestrians in any hour was the signalized intersection of CR 43 and CR 44. These pedestrians were high school students on their lunch break. Compliance with the pedestrian signals was poor and students also crossed outside of the crosswalk area. As shown in **Photo 1**, students crossed diagonally through the right turn bypass lane after walking on the shoulder.

Photo 1 - Pedestrians Out of Crosswalk

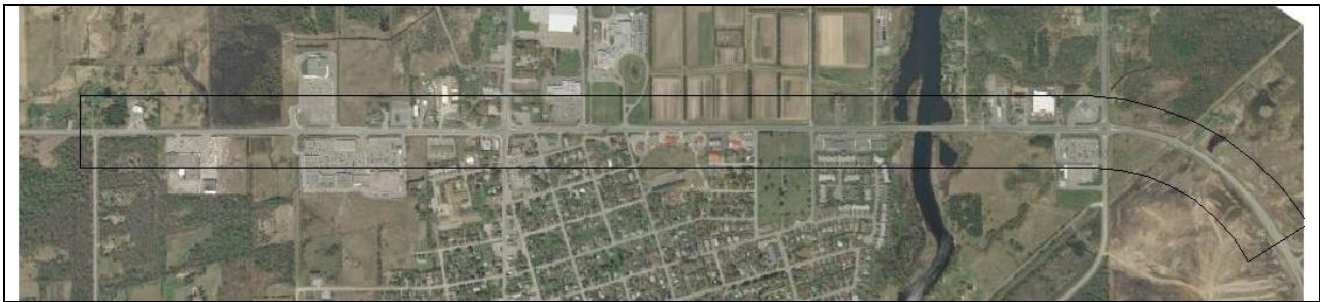
Figure 1. CR43 Study Area

See Figure 1 for an illustration of the study area.

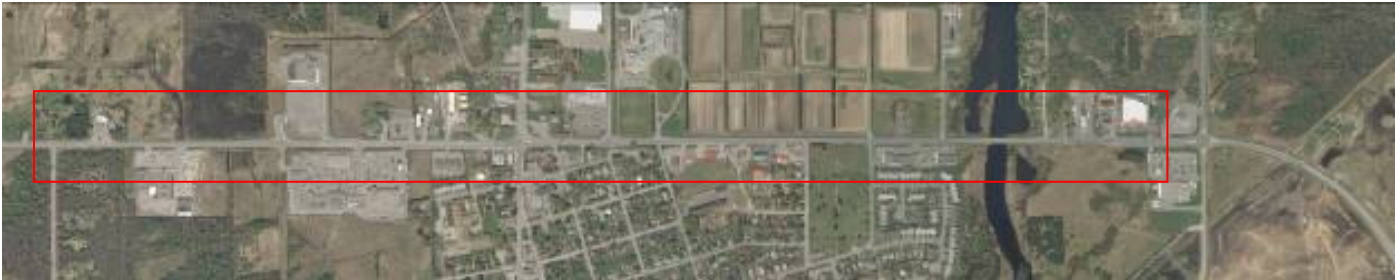
Figure 1. Study Area

On April 17, 2009, a site visit was completed to determine the existing land uses along the corridor. Appendix A provides an overview of the corridor and the existing land uses along the corridor.

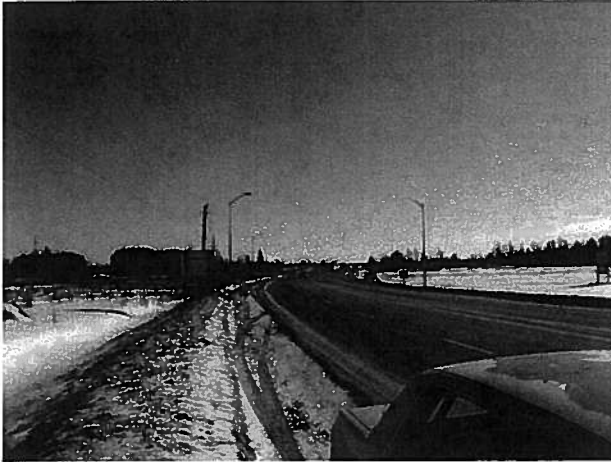
Plate 1: Looking south-east along CR43 at 416 interchange at undisturbed fallow fields beyond disturbed right-of-way

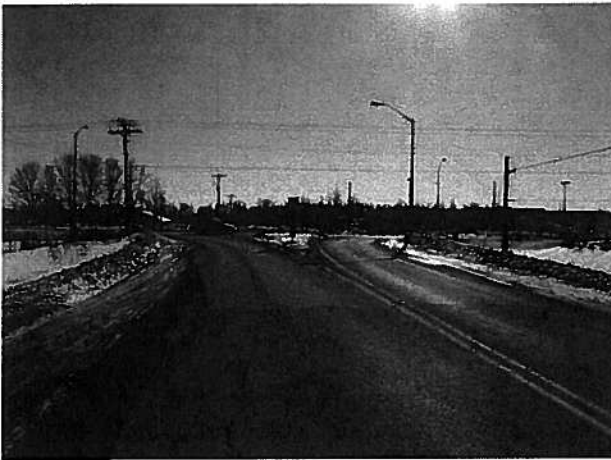
Plate 2: Looking south along County Road 19 at disturbances associated with the roundabout intersection with County Road 43

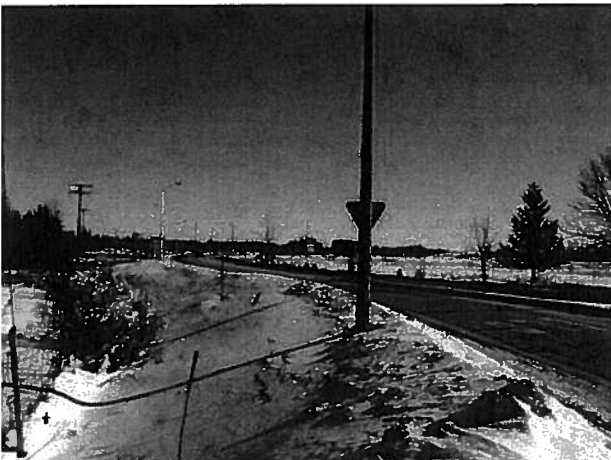
Plate 3: Looking east along north side of County Road 43 from CR 19 roundabout at disturbances associated with ditching. Note undisturbed fallow fields beyond ROW limits

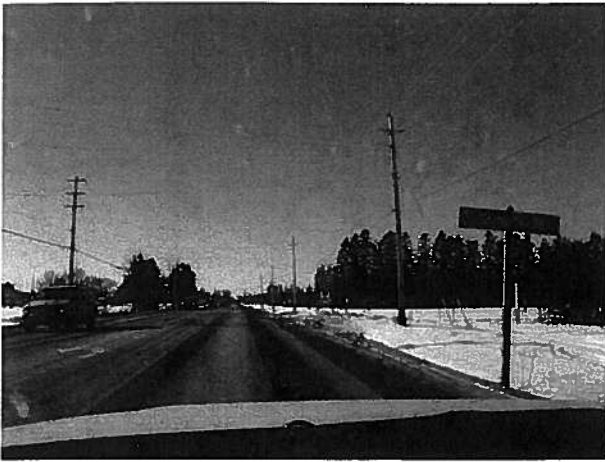
Plate 4: Looking west along County Road 43 on northern side of Grenville St. Intersection at undisturbed fields beyond disturbed right-of-way

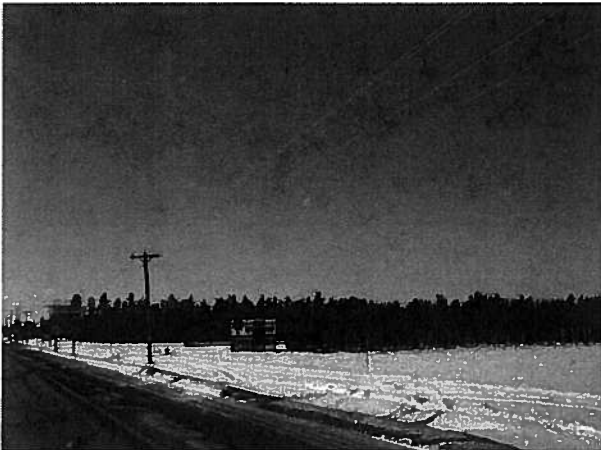
Plate 6: Looking west along County Road 43 at the Ferguson Forestry Centre and undisturbed fields beyond disturbed right-of-way

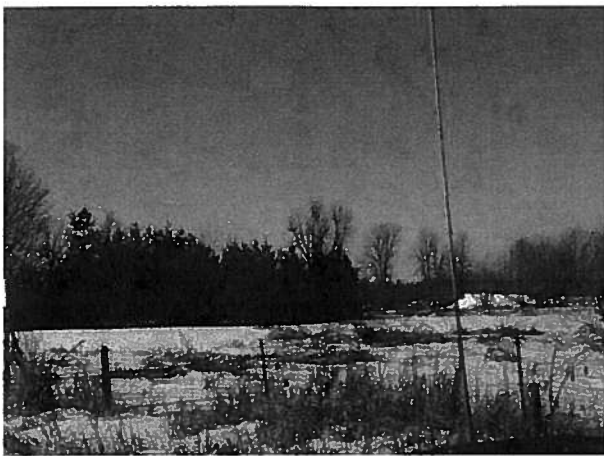
Plate 8: Looking north on County Road 43 at future Oxford Village site at undisturbed fallow field beyond disturbed right-of-way

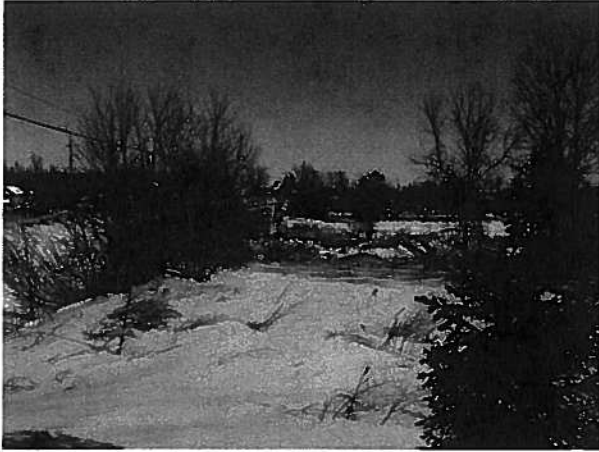
Plate 10: Looking east at open fields on the southside of Kemptville Creek from Creekside centre
